A Review of Recent Tower Crane Accidents and the Lessons Learned

Tim Watson
Tim Watson Consulting Limited

Tower Crane Accidents

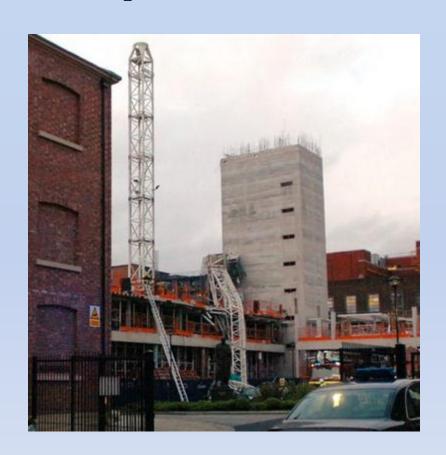
Environment Liverpool - January 2007

- Luffing tower crane
 - 3 years old
 - CE marked
 - DOC to EN 14439
- Crane was in use
 - Light load
 - Close to minimum radius
 - Wind near maximum inservice limit
- Jib fell backwards across the site during a lifting operation
- 1 Construction worker killed

- Jib at small angle to the vertical
- Wind from the front held the jib up and caused the luffing rope to go slack
- Luffing rope jammed in the sheaves
- Operator tried to lower off and paid out rope from the luffing winch, which looped down the back of the crane
- Luffing rope became free allowing the jib to drop until the slack rope arrested its fall
- Large dynamic load caused the jib to fail and the slewing section and counter jib became detached from the top of the tower at the slew ring
- One of the counterweights fell on a construction worker causing fatal injuries
- Issues:
 - Crane design standard

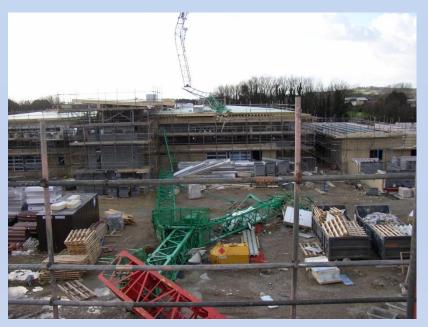
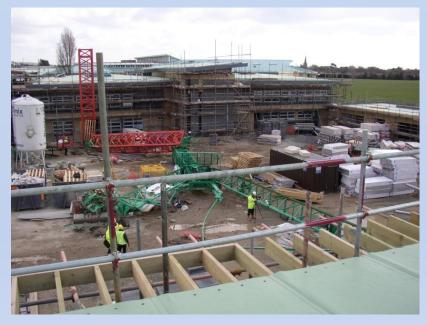
Human Factors Worthing – February 2005

- Two men killed
- One seriously injured

- De-rigging prior to dismantling
- The two erectors fatally injured working on the jib removing hoist and trolley ropes
- Third Erector had de-torqued tower bolts on one side of the mast
- Jib was slewed
- Slackened bolts failed and crane collapsed
- Crane owner prosecuted and fined £389,000 for not managing the dismantling process effectively
- Issues
 - Training
 - Planning

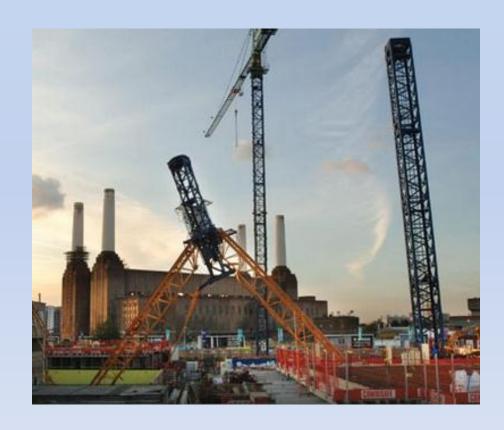
Mechanical Issues Battersea – September 2006

- Saddle jib tower crane
- Twenty seven years old
- Crane had been in use for a number of weeks after erection
- Bolts in the joint below slew ring failed through fatigue
- Jib fell across site into an adjacent road
- Crane Driver + Member of public killed
- Slew ring bolts had been replaced in the air, shortly after erection
- Crane had been erected with too much counterweight
- Issues:-
 - Information and Planning
 - Maintenance
 - Thorough Examination

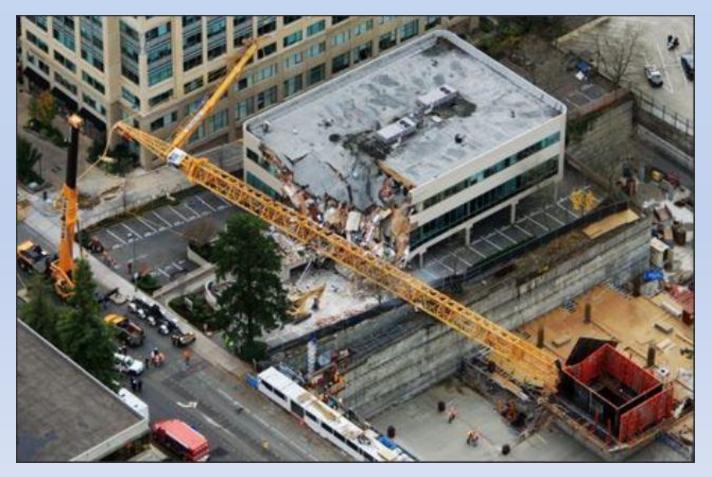
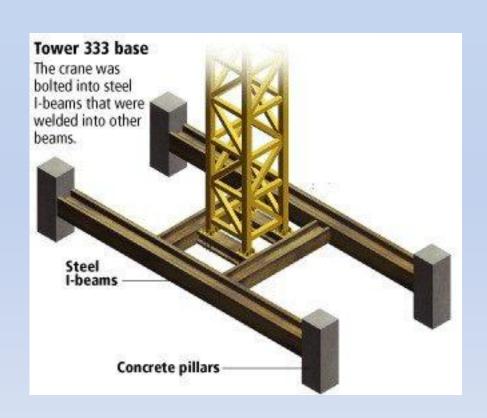
Human Factors and Structural Seattle – November 2006

- Official enquiry blamed inadequate design of foundation
- Fatigue failure
- Lack of maintenance and inspection
- Issues:
 - Planning
 - Base design
 - Maintenance
 - Thorough examination

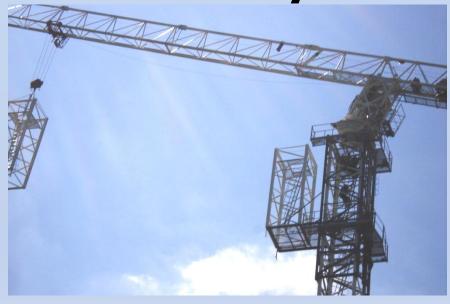
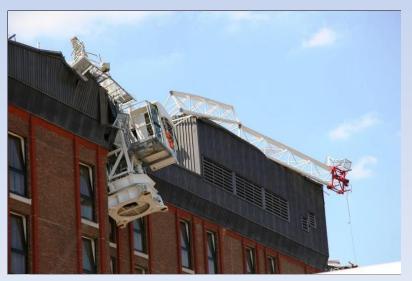
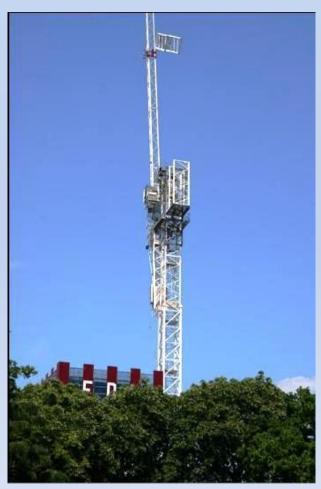
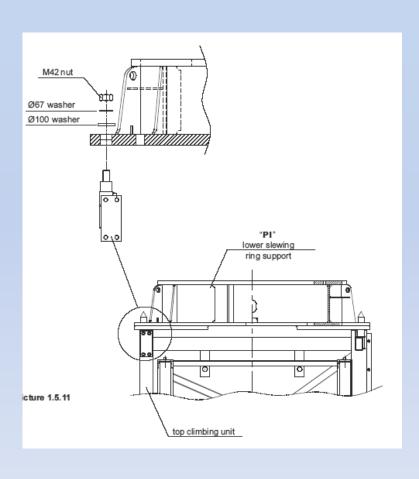
Human Factors Croydon – June 2007

- Climbing team had not used the equipment before and had not had any specific training on its use
- Crane owner fined
 £100,000 + £33,196 costs
- Issues
 - Training
 - Planning
 - Not following manufacturer's instructions

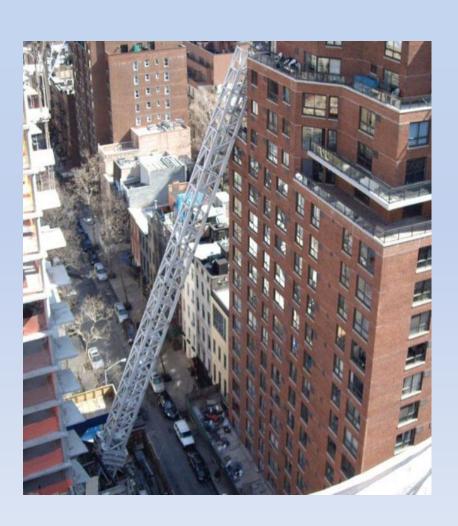
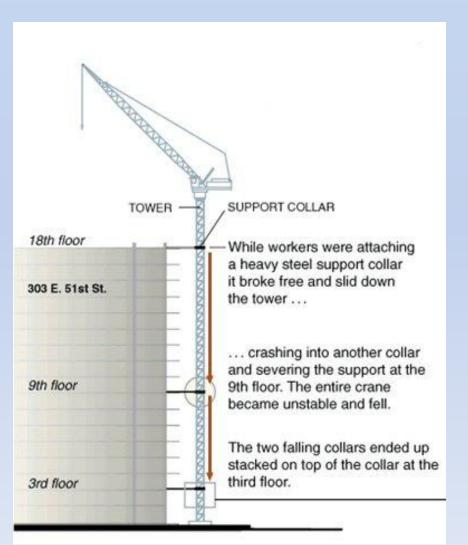
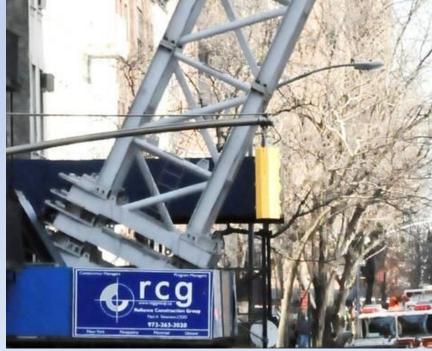
Structural New York – March 2008

- Luffing Jib Tower Crane
- 7 Fatalities
- Tie collar being attached
- Fabric lifting sling failed, causing tie to fall
- Top of crane demolished building two blocks away
- Issues
 - Planning
 - Selection of equipment

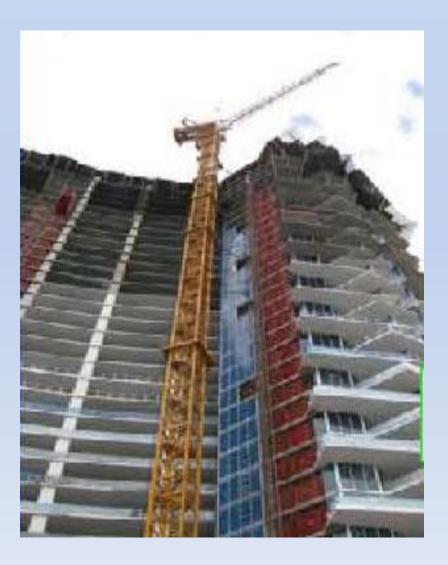
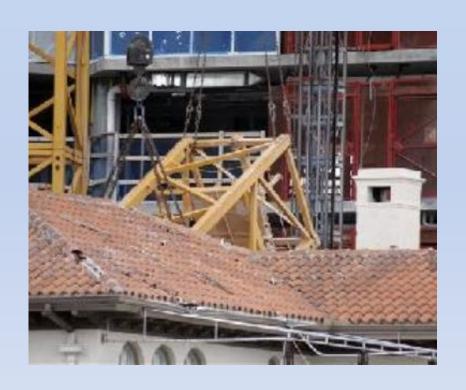
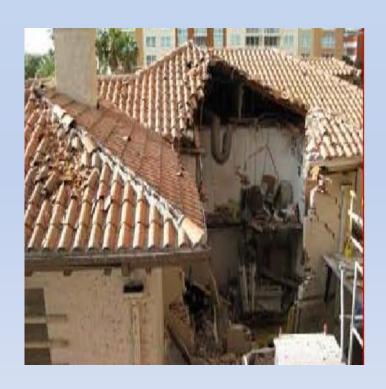
Human Factors Miami – March 2008

- Libeherr luffing jib crane
- Climbing operation
- Tower section fell
- 2 Fatalities
- Issues:-
 - Planning
 - Selection of equipment

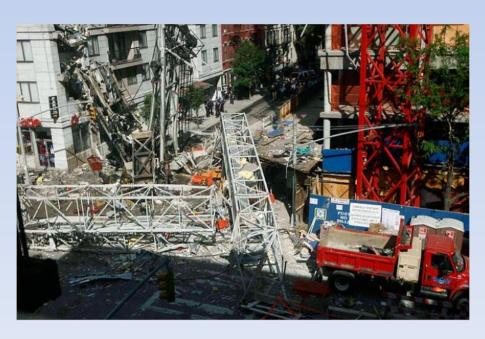
Human Factors/Structural New York - May 2008

- 24 years old Kodiak luffing tower crane
- In-service but not lifting
- 2 Fatalities
- Slew ring support failed
- Had been repaired in China
- Issues:-
 - Maintenance
 - Thorough examination

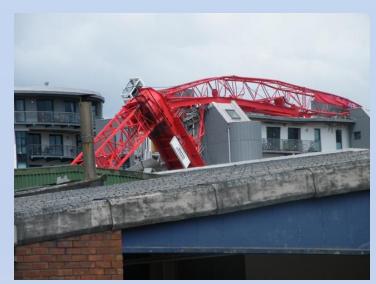
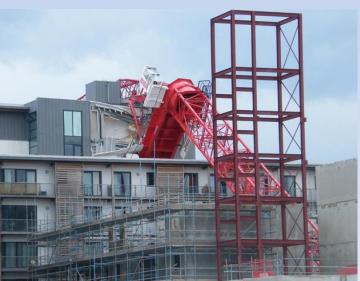
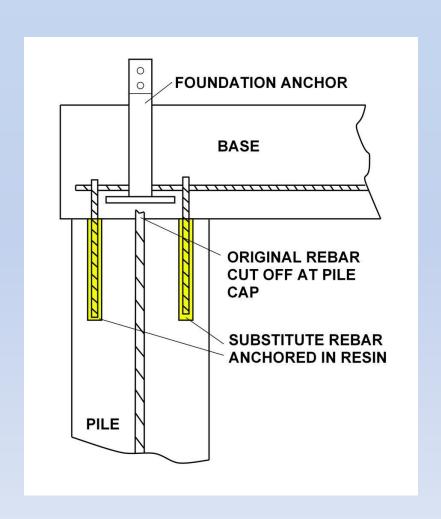
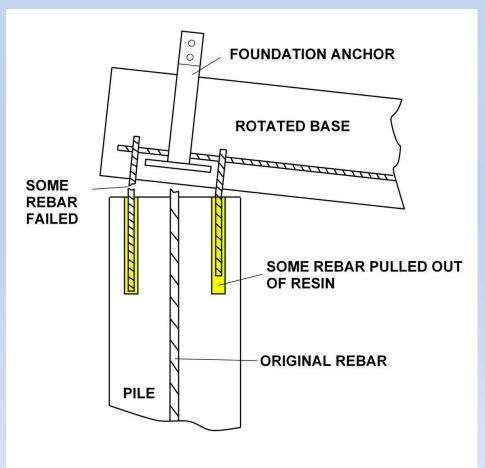
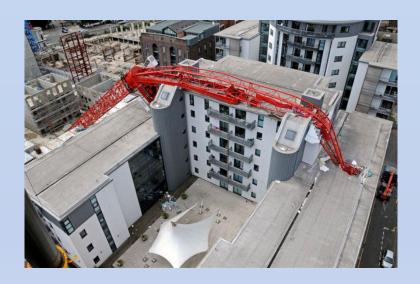
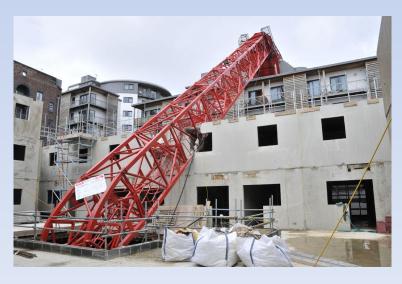
Human Factors/Structural Liverpool July 2009

- Luffing jib crane
- Lifting a light load at a small radius
- Witnesses reported hearing "two loud bangs"
- Tower crane collapsed onto an adjacent apartment building
- Counterweights fell through roof
- Operator fell out of cab and through hole in roof

- Base Designer had no previous experience of designing this type of foundation
- Principal Contractor's employees had no previous experience of building this type of foundation
- Contractor fined £280,000 (\$450,000) (€350,000)
- Designer went into administration
- Issues:-
 - Poor design
 - Poor construction
 - Lack of experience

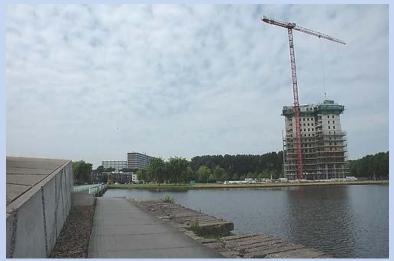
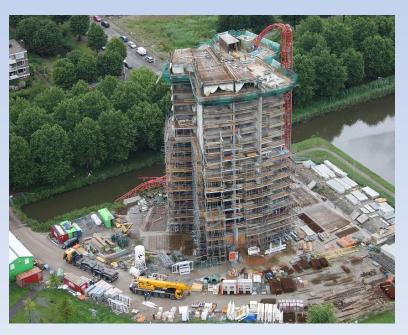
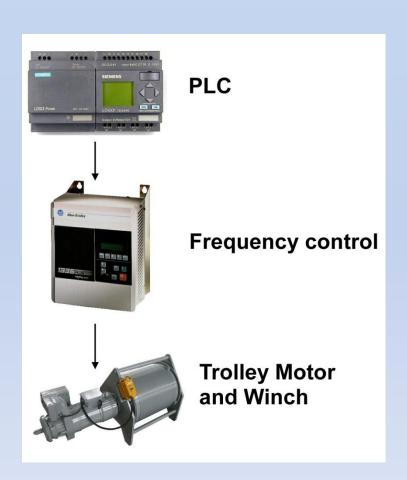
Human Factors/Electrical Rotterdam – July 2008

- Lifting a heavy load (balcony slab) within its rated capacity close to the mast.
- Slewed and trolleyed to near maximum radius for the load
- Trolley stationary and held on mechanical brake
- The jib and mast had deflected under load
- Trolley control operated to bring trolley in before final positioning
- Instead of moving towards the mast the load ran away to the outer end of the jib
- Crane was overloaded and the mast failed just above the a transition section

- Trolley winch travel motor control system was a PLC/Inverter electronic system
- The incident was attributed to settings of the control system
- When the trolley control was operated the trolley motor mechanical brake was released before the motor had built up sufficient torque to hold the load against the downward slope of the crane jib
- Issues:-
 - Poor design
 - Inadequate hazard analysis
