A Review of Recent Tower Crane Accidents and the Lessons Learned

Tim Watson
Tim Watson Consulting Limited

Tower Crane Accidents

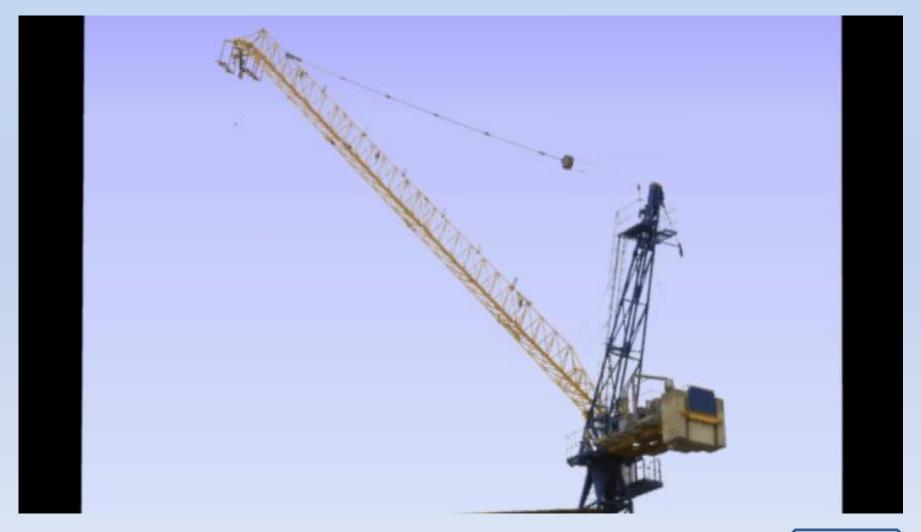
Liverpool Animation

- Jib at small angle to the vertical
- Wind from the front held the jib up and caused the luffing rope to go slack
- Luffing rope jammed in the sheaves
- Operator tried to lower off and paid out rope from the luffing winch, which looped down the back of the crane
- Luffing rope became free allowing the jib to drop until the slack rope arrested its fall
- Large dynamic load caused the jib to fail and the slewing section and counter jib became detached from the top of the tower at the slew ring
- One of the counterweights fell on a construction worker causing fatal injuries
- Issues:
 - Crane design standard

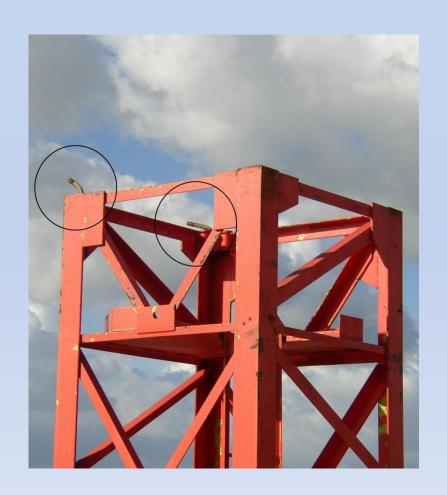
Worthing – February 2005

- De-rigging prior to dismantling
- The two erectors fatally injured working on the jib removing hoist and trolley ropes
- Third Erector had de-torqued tower bolts on one side of the mast
- Jib was slewed
- Slackened bolts failed and crane collapsed
- Crane owner prosecuted and fined £389,000 for not managing the dismantling process effectively
- Issues
 - Training
 - Planning
